# Manhole Inspection Summary

Manhole # S21M\_\_033MH

Insp Date: **3/21/08 11:34 AM**

**Location** Address: **1828 s addison st**

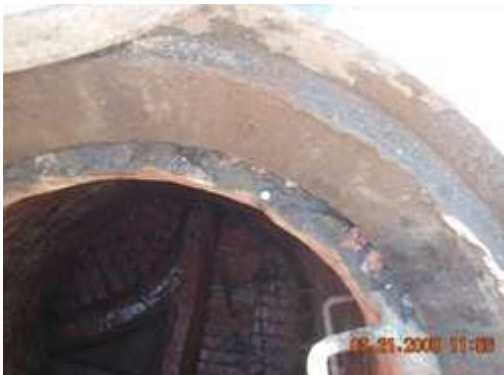
Defect 3

Offset: **1** (in.)

frame offset

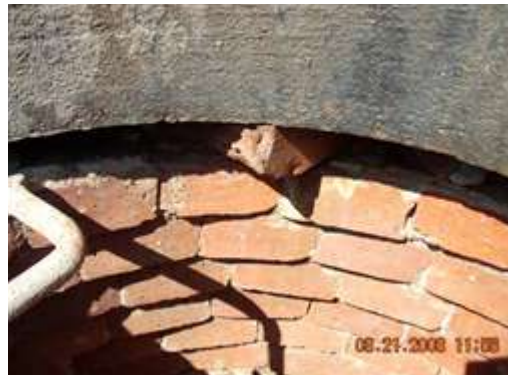
Defect 2

Condition: ☐ Sound ☐ Cracked ☐ Root Intrusion ☒ Loose Brick ☒ Deteriorated

loose chimney brick

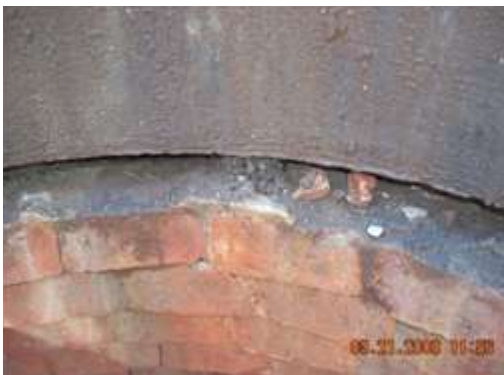
Defect 1

deteriorated chimney

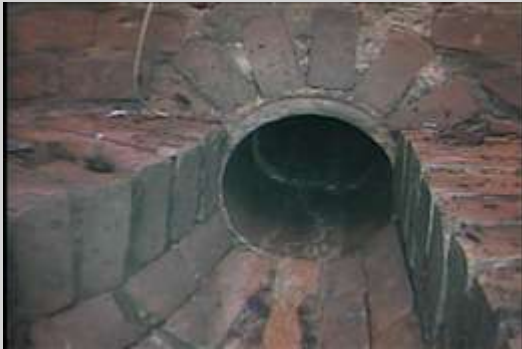
12 O'Clock Outflow

8 in. Circular Gravity Sewer  
Pipe Out @ 12 O'Clock

Pipe Height: **8.4** (in.) Rod and Bar (Angled)  
Pipe Material: **Clay** ☐ Pipe Lined  
Invert Depth: **8.43** (ft.) Flow Characteristics: **Slow**  
Deposits: ☒ None ☐ Mud ☐ Sludge ☐ Debris ☐ Grease  
Silt Depth: **0** (in.) Deposits Extent:  
Infiltration: **None** Pipe Seal Cond: **Sound**

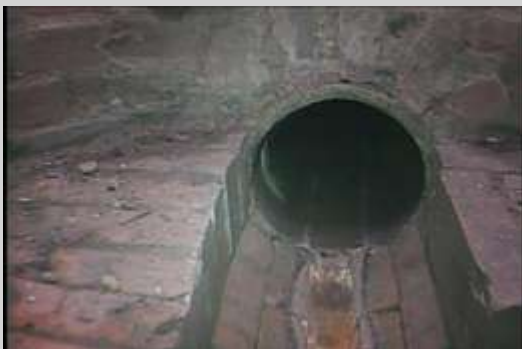
6 O'Clock Inflow

8 in. Circular Gravity Sewer  
Pipe In @ 6 O'Clock

Pipe Height: **8.4** (in.) Rod and Bar (Angled)  
Pipe Material: **Clay** ☐ Pipe Lined  
Invert Depth: **8.19** (ft.) Flow Characteristics: **Slow**  
Deposits: ☒ None ☐ Mud ☐ Sludge ☐ Debris ☐ Grease  
Silt Depth: **0** (in.) Deposits Extent:  
Infiltration: **None** Pipe Seal Cond: **Sound**

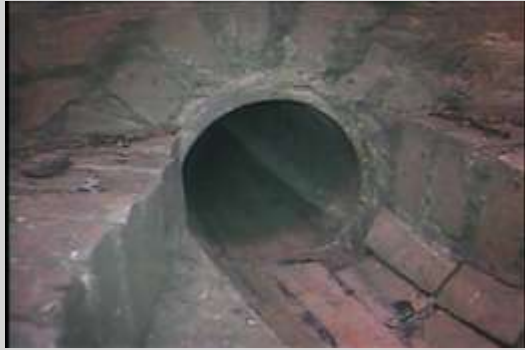
8 O'Clock Inflow

Pipe In @ 8 O'Clock

Pipe Height: **7.2** (in.) Rod and Bar (Angled)

Infiltration: **None** Pipe Seal Cond: **Sound**
